CLIFF FACE STABILISATION WORKS ROCKS ROAD NELSON

Stuart Palmer
Beca Carter Hollings & Ferner Ltd

Paul Denton
Montgomery Watson New Zealand Ltd

SUMMARY

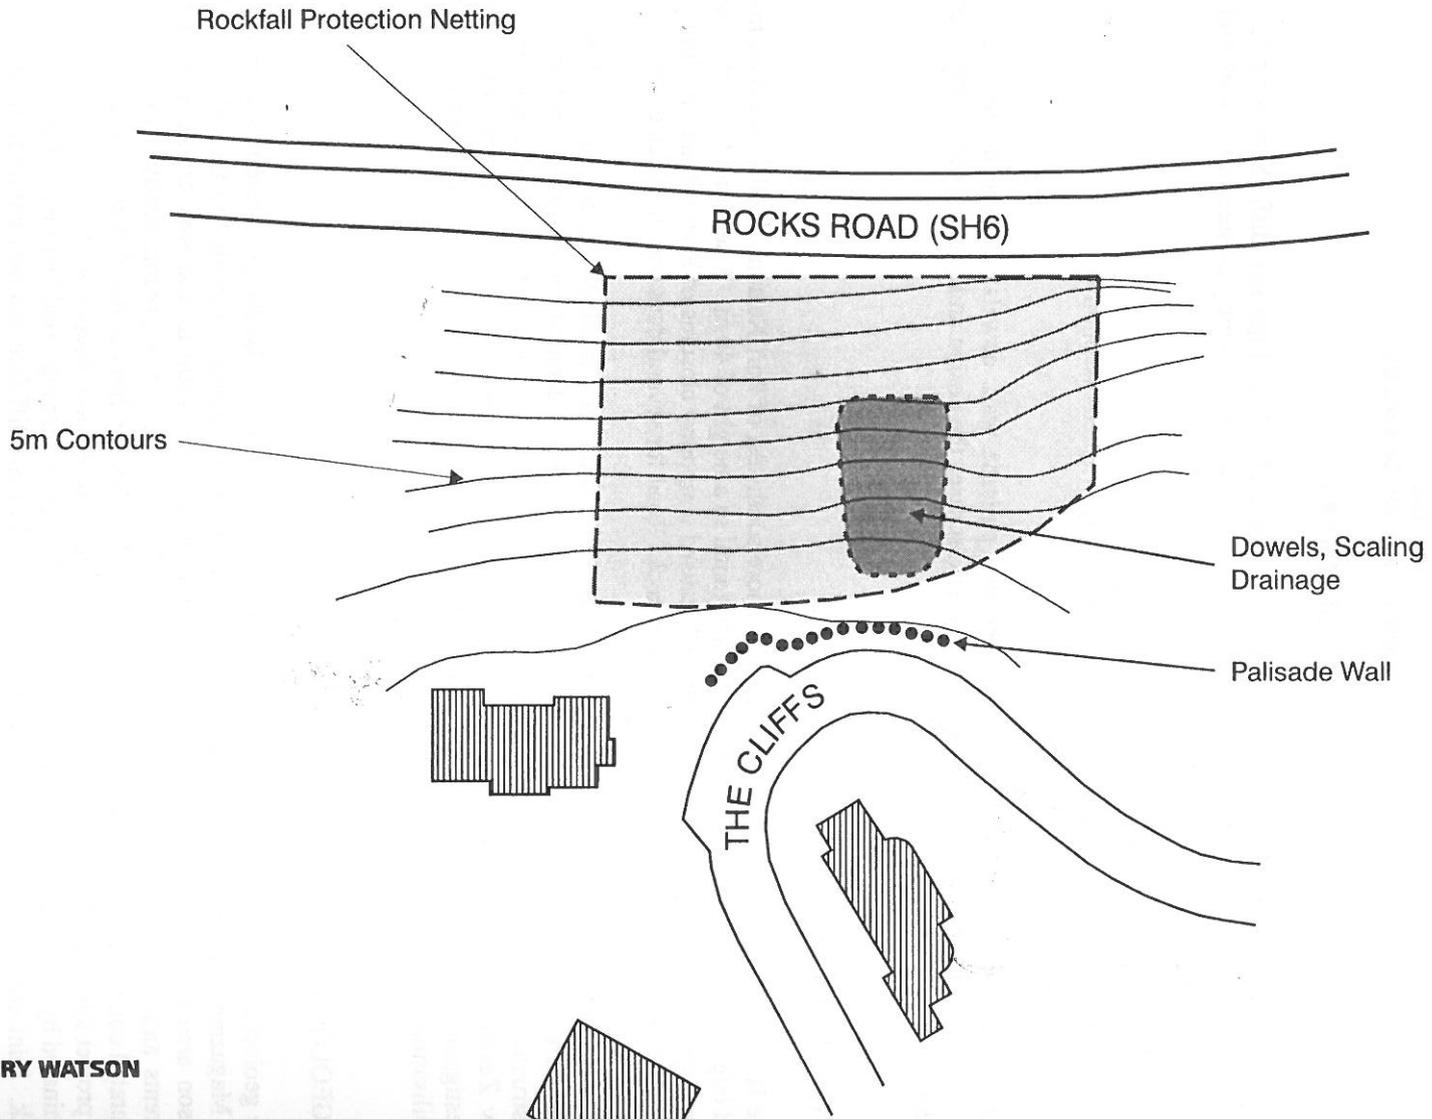
Figure 1

Three mechanisms of past and/or potential instability had been identified. These were; (a) creep movement of fill at the crest of the cliff, (b) block failures of rock on the joint set sub-parallel to the cliff face, and (c) raveling of the rock face. Respective techniques employed to remedy these mechanisms of instability were; (a) a palisade of reinforced concrete piles, (b) dowels and inclined drains, and (c) scaling and rockfall protection netting. Figures 1 and 2 show the areas of potential instability in plan and section.

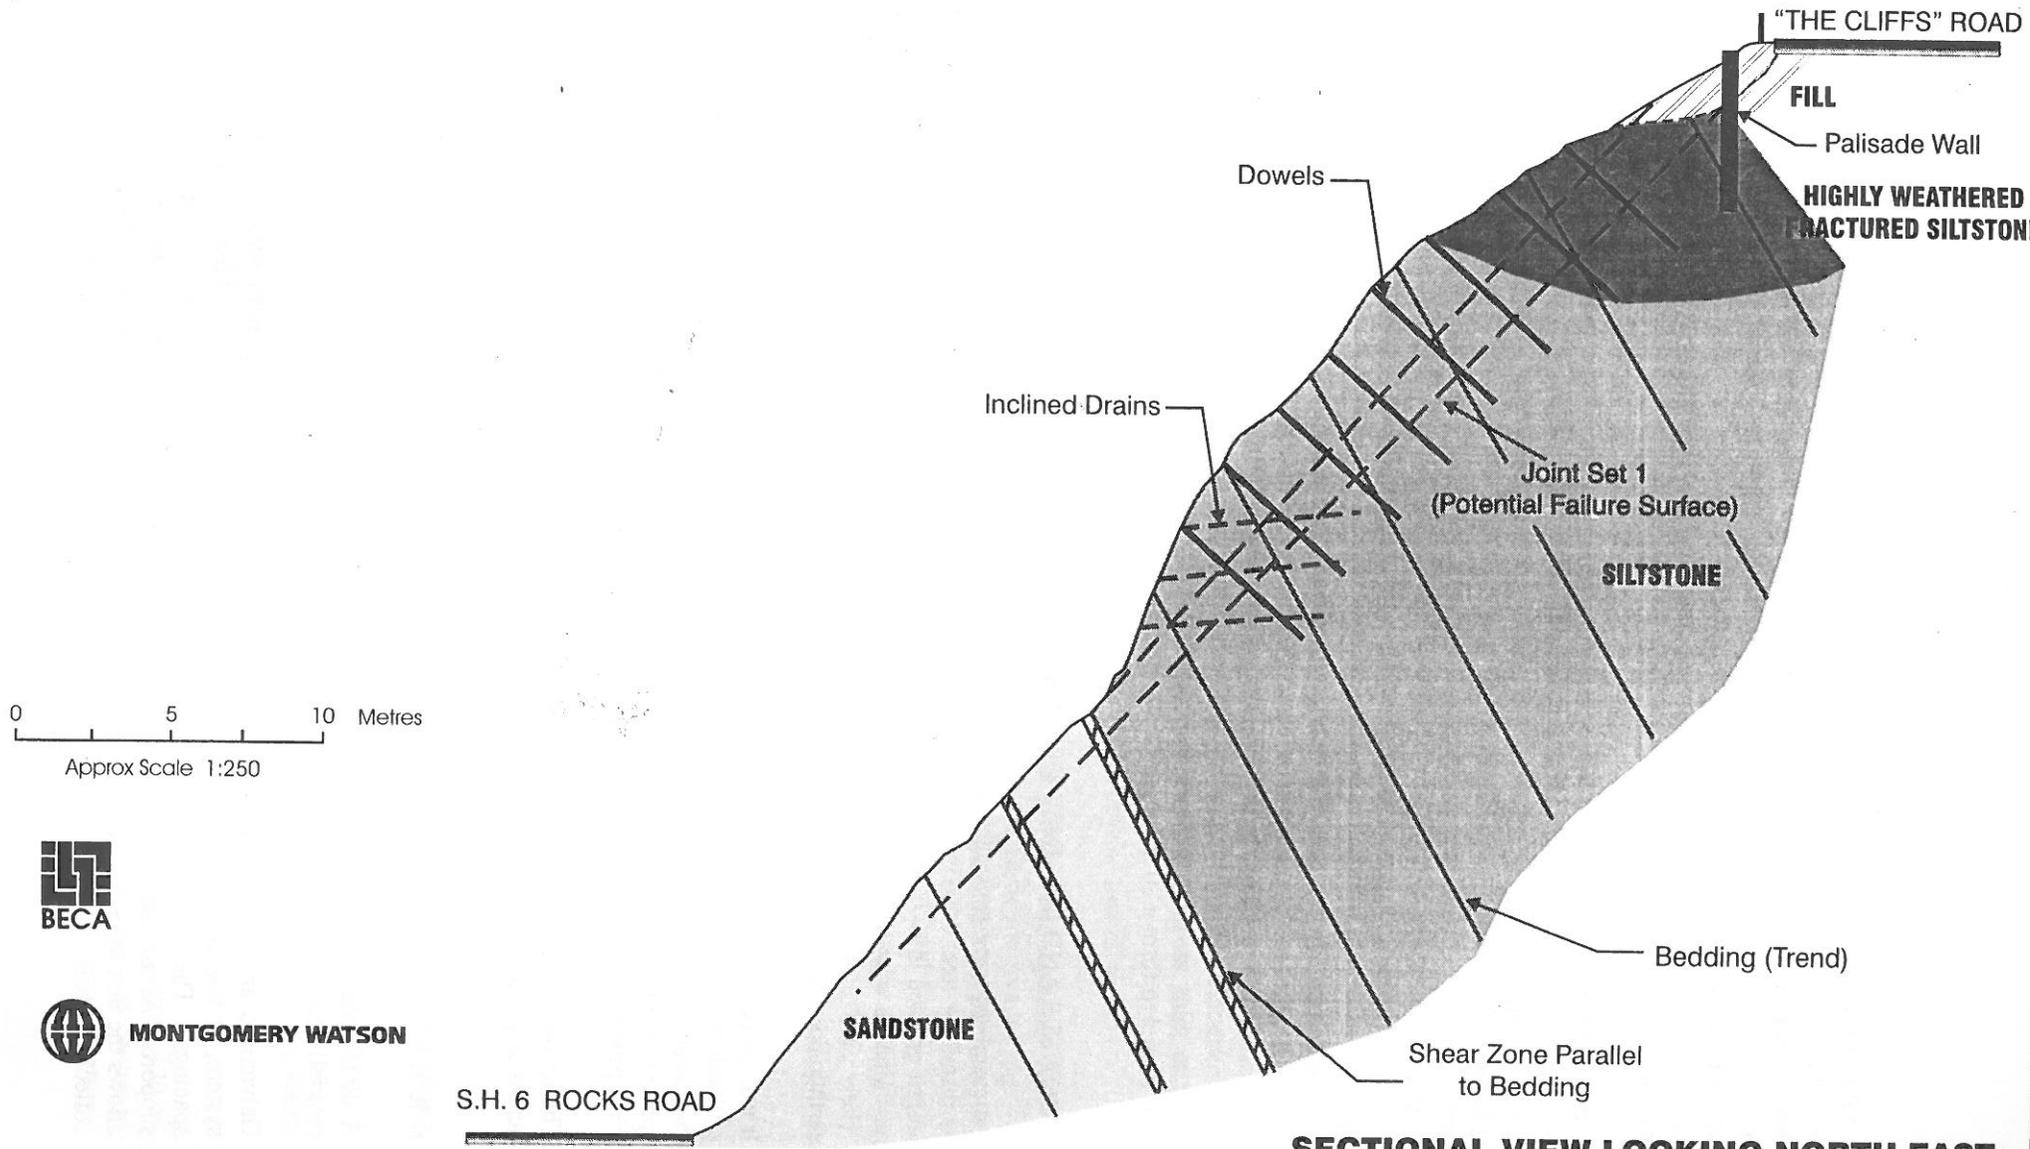
SECTIONAL VIEW LOOKING NORTH EAST
Figure 2

The geologic structure of the cliff face is summarised on Figure 2. Sandstone, siltstone and mudstone of the Magazine Point Formation dips into the cliff at 60° with a strike subparallel to the cliff face. In the Nelson area the total thickness of this unit probably exceeds 1500 m and was deposited by turbidity currents and submarine debris flows in an early Tertiary sea. It is predominantly a moderately well indurated competent sandstone, well exposed on the foreshore in front of the cliff at low tide. However, at the project site, higher up the stratigraphic column the unit is more deeply weathered, less competent and dominated by siltstone which has given rise to rockfalls and slumping. Bedding ranges from 50 mm to 1 m thick. Joint defects include a dominant set sub-parallel to the cliff face and daylighting from the cliff face. This joint set is identified as joint set 1 on Figure 2. The cliff is 40 metres high having been formed by erosion and undercutting of the sea during the post glacial **period** over the past 6000 years. Erosion and subsequent oversteepening **of** this old sea bluff continued until construction of State Highway 6 in 1893.

Increased shearing resistance along the potential failure planes of joint set 1 (refer Figure 2) was provided by installing steel dowels and inclined drains. The steel dowels comprised HD40 reinforcing bars of 6 m length grouted into 75 mm diameter holes drilled perpendicular to the joint set. These steel dowels were provided on a grid of 3 m spacing downslope and 3 m spacing across slope. The dowels are to act as “shear pins” and were sized to increase the factor of safety against shear failure for both the static and the earthquake design case.
