Housing Development on a Large, Active Landslide: The *Tahunanui Slump* Story, Nelson, New Zealand

Paul C Denton
Mike R Johnston
Soils & Foundations Ltd, Nelson

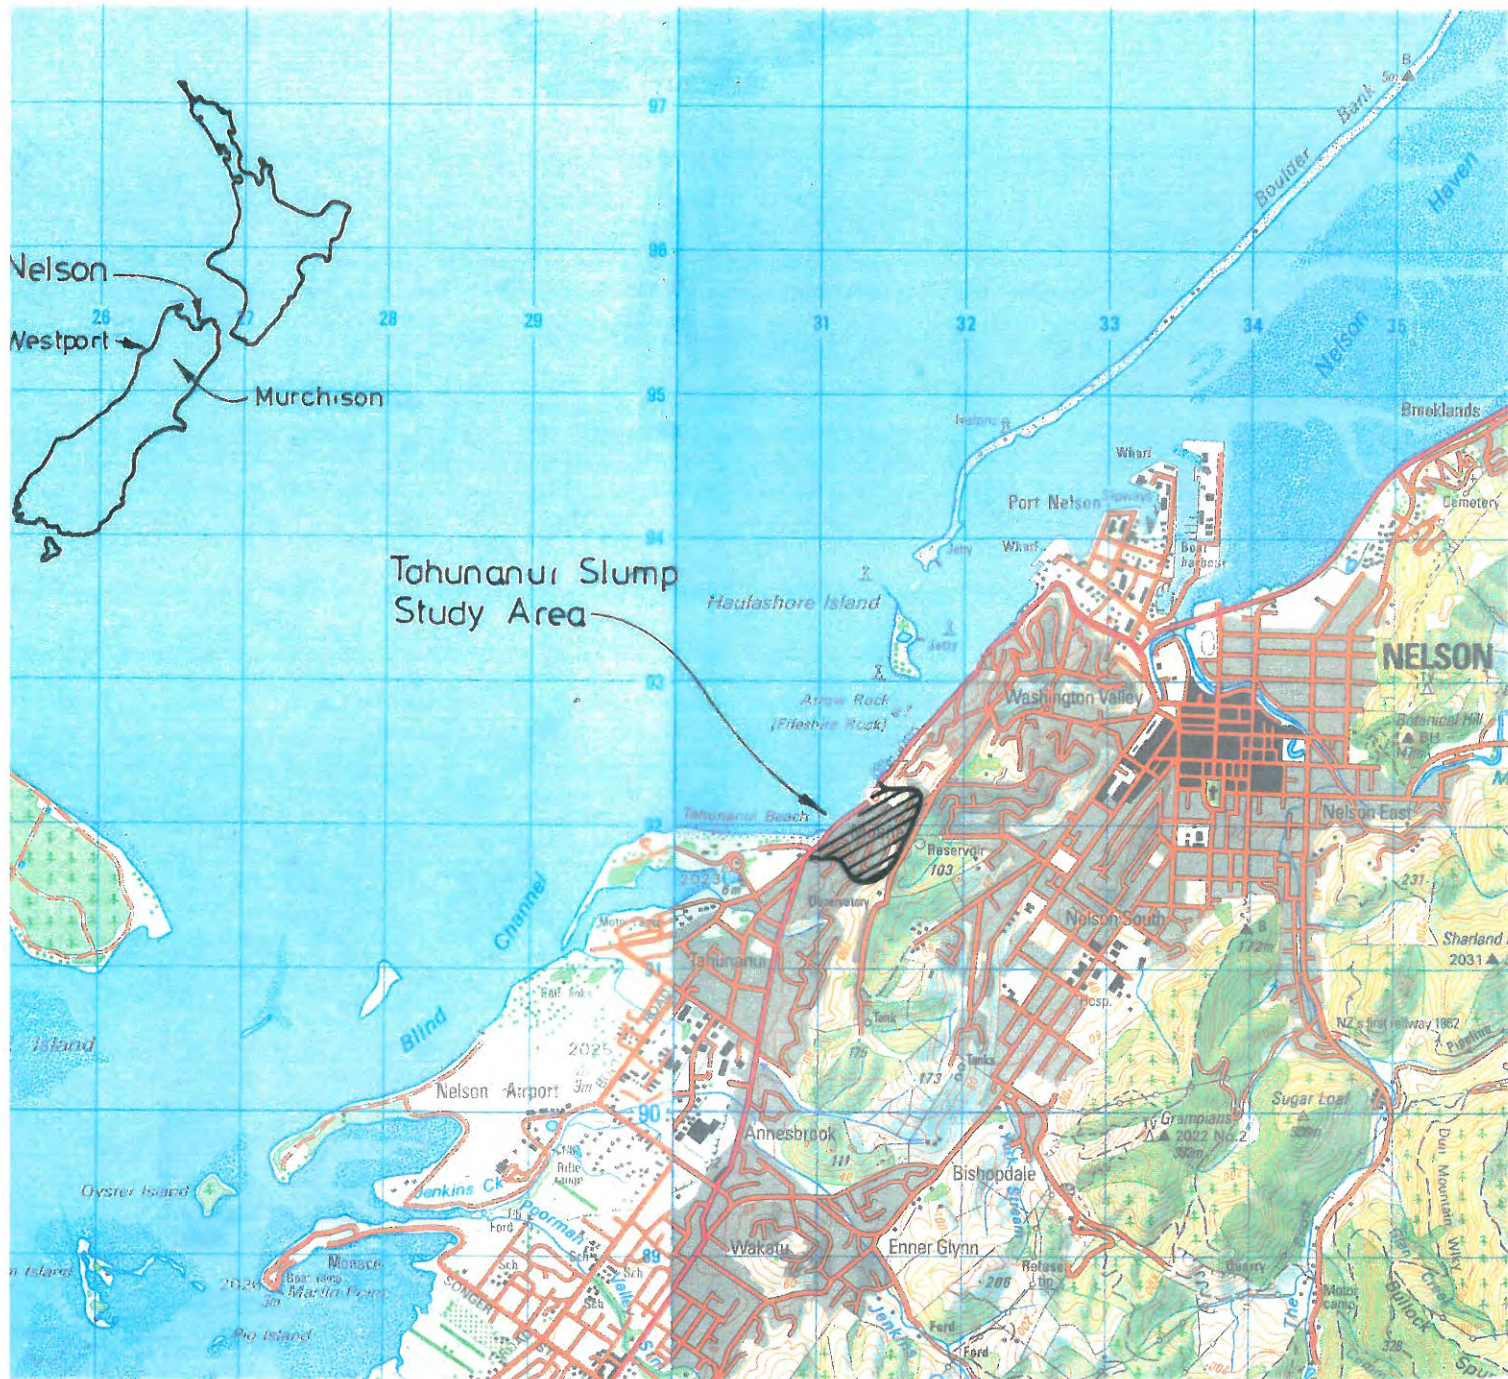
Tahunanui Slump Location Plan

The approximate boundaries of the *Tahunanui Slump* as well as the major subsidiary failures within it are indicated in plan (Figure 1) and in schematic cross-section (Figure 2). The rates and nature of movements within these subsidiary blocks differ substantially as generally indicated by both the periodic resurvey records and the distribution and character of historic failures.

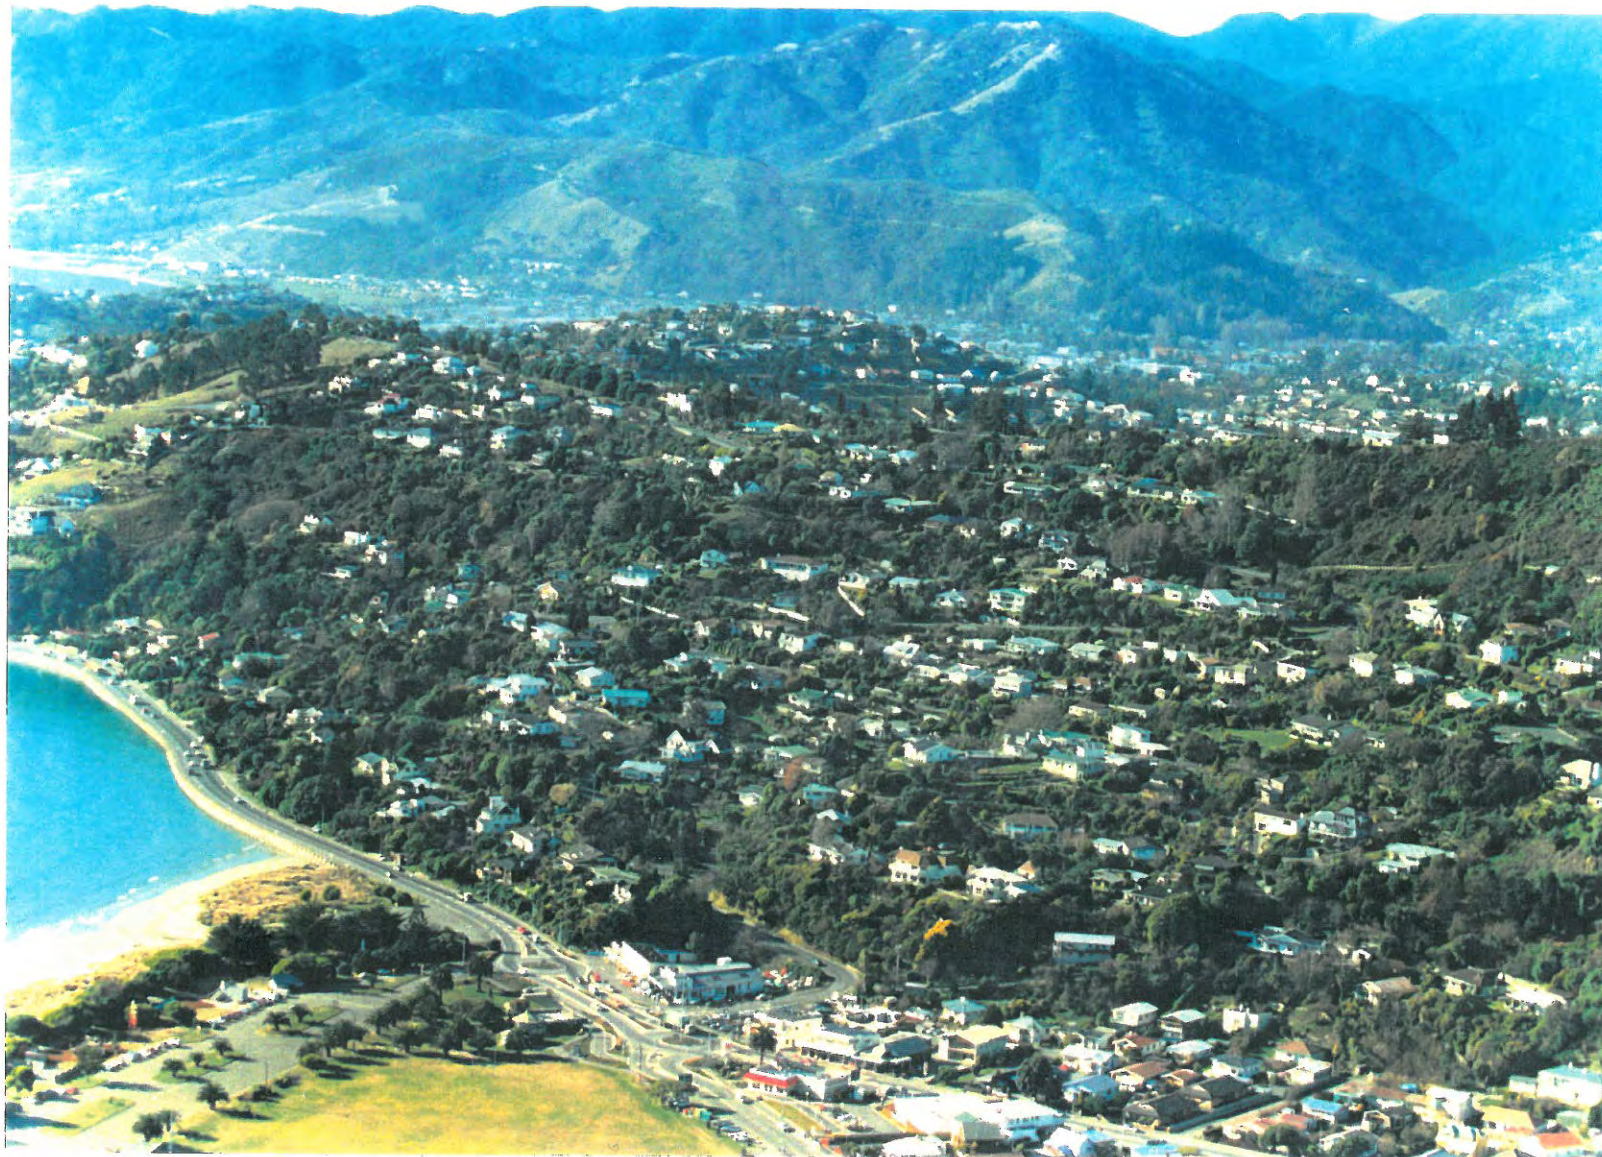
PHOTO 1: Tahunanui Hillside looking northeast showing the extent of residential development on the active *Tahunanui Slump*. PHOTO CREDIT: Nelson Mail, 1994

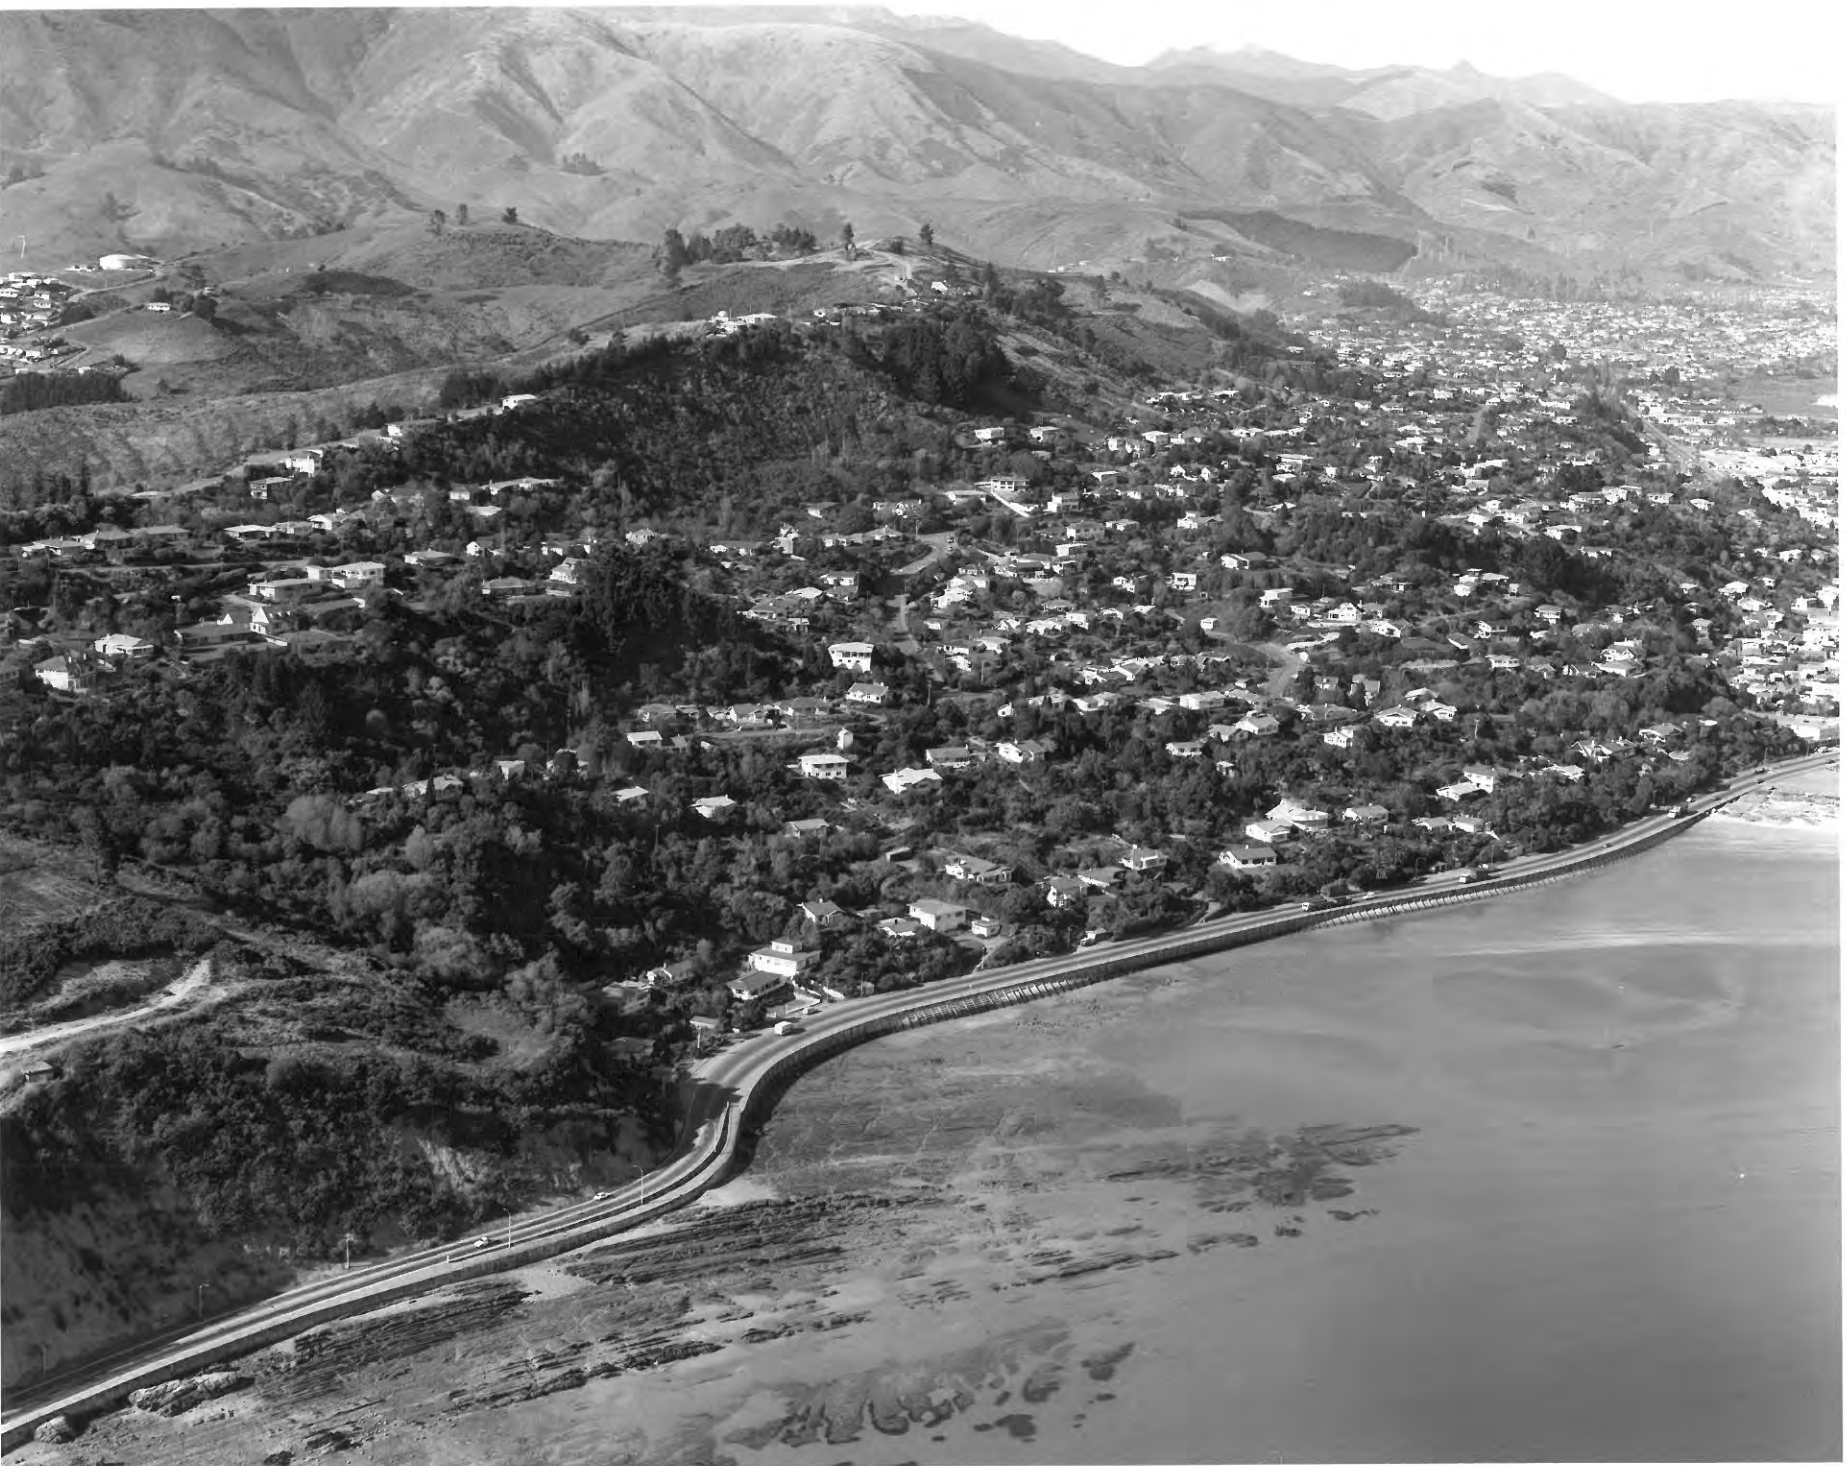
PHOTO 2: Tahunanui Hillside looking south showing the active *Tahunanui Slump*. Visible are a 75m high headscarp, the absence of scarpcliffs at its toe (between Magazine Point in foreground and the shops opposite Tahunanui Beach) and bulges in the seawall. PHOTO CREDIT: D L Homer, Institute of Geological & Nuclear Sciences Ltd, 1978

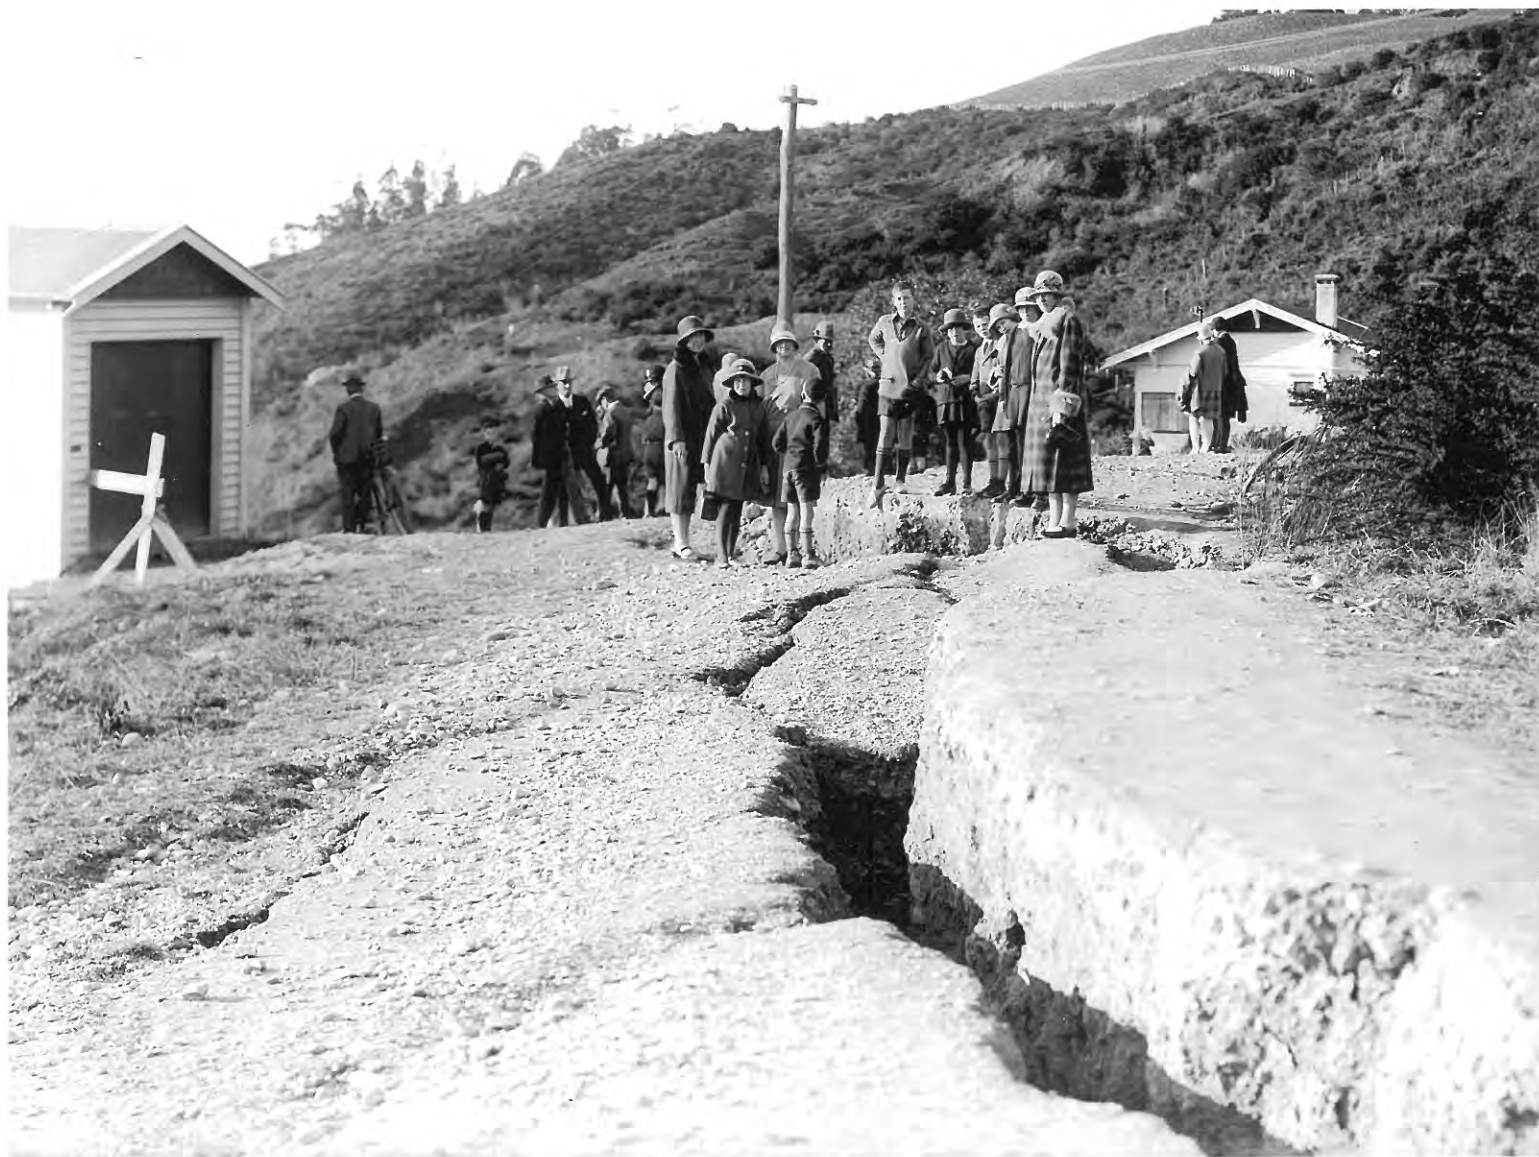
aftershocks affected the area in the weeks that followed. Approximately one month later, during the night of 13 - 14 July 1929 two houses were wrenched off their foundations by landsliding adjacent to major road cracking. Local newspaper accounts reported an area of 2 ha was involved and that the hillside moved 5 metres down and across Rocks Road at the toe. Surface bulging of the road, involving some 3 metres of carriage width, was reported.

PHOTO 4: Edward Street (now Grenville Terrace) near Bisley Avenue looking southeast near head of 1929 movement showing recent damage in the lower central portion of the *Tahunanui Slump*.

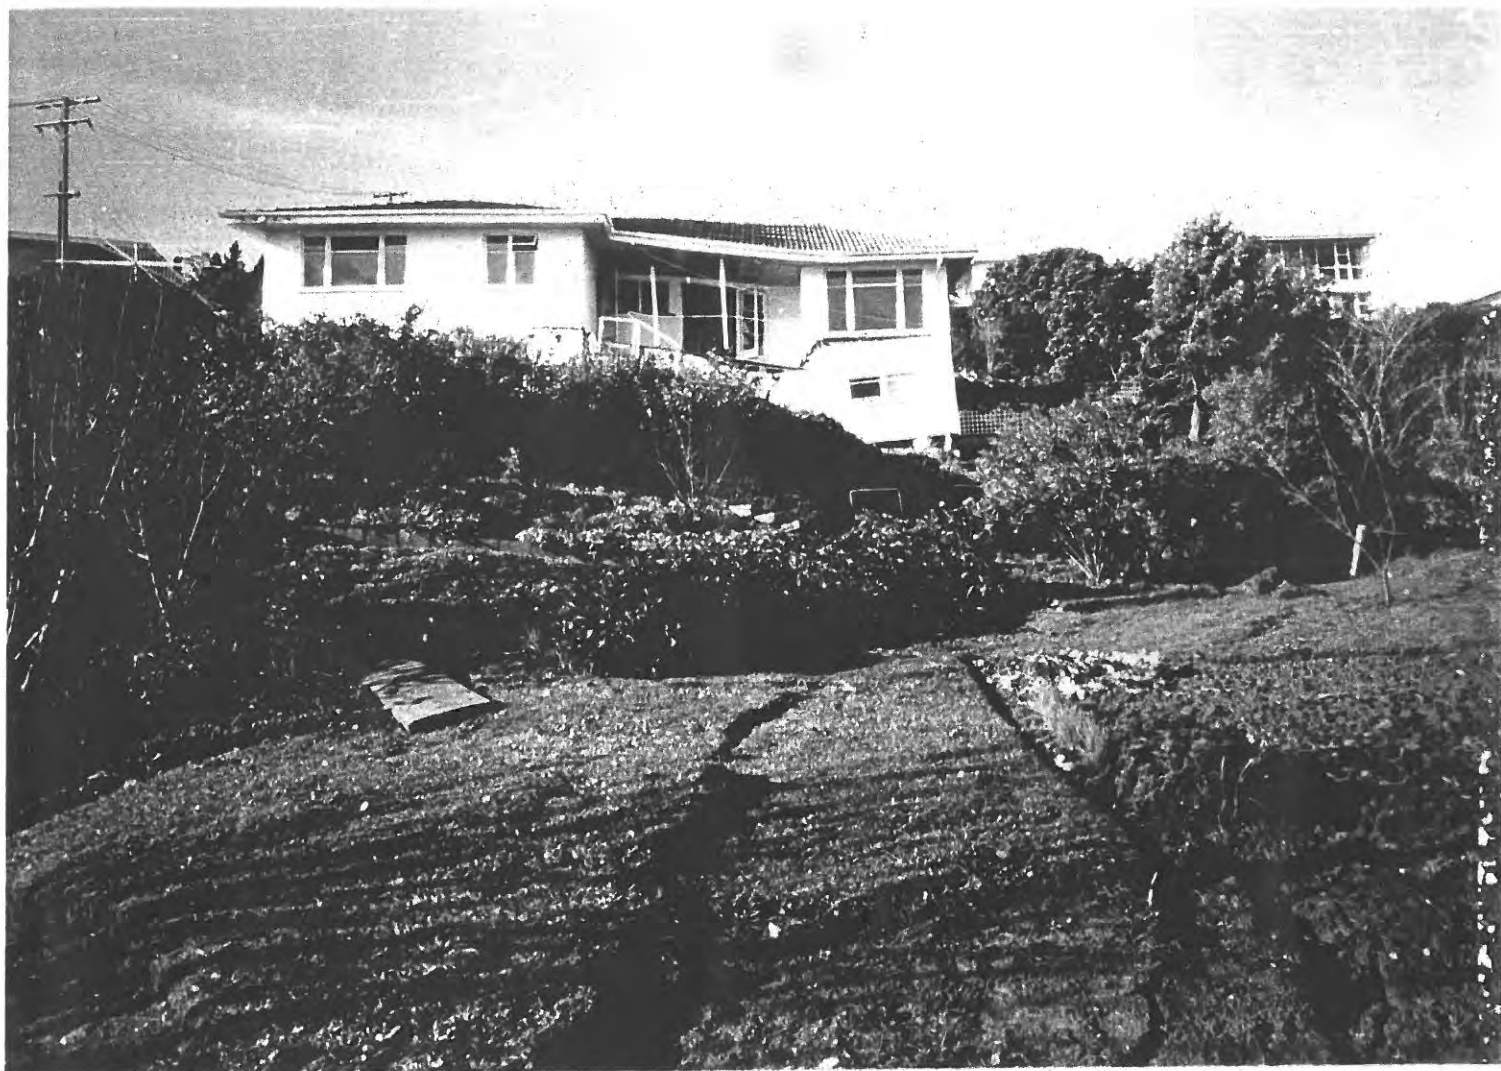
1962 On 10 and 17 May 1962, moderate earthquakes centred near Westport (RM 5.9) shook the area with a felt intensity of MM IV. 1962 had also been the wettest year since reliable records were begun in 1862 and approximately two weeks following these earthquakes, there was further heavy rain in the area. On 1 June 1962 damaging movement occurred within the slump and of nine houses that were directly affected, four suffered serious damage with at least one being condemned and torn down. An area of 1 ha immediately above Rocks Road and south of the 1929 movement was affected. Minor movement and damage was recorded elsewhere, being widely distributed throughout the body of the slump. Further movement occurred following wet weather later that year and may have been related to the removal of toe support during the 1 June failures.

Photo 5: Bisley Avenue Area Damage 1962
