Housing Development on a Large, Active Landslide: The *Tahunanui Slump* Story, Nelson, New Zealand

Paul C Denton
Mike R Johnston
Soils & Foundations Ltd, Nelson

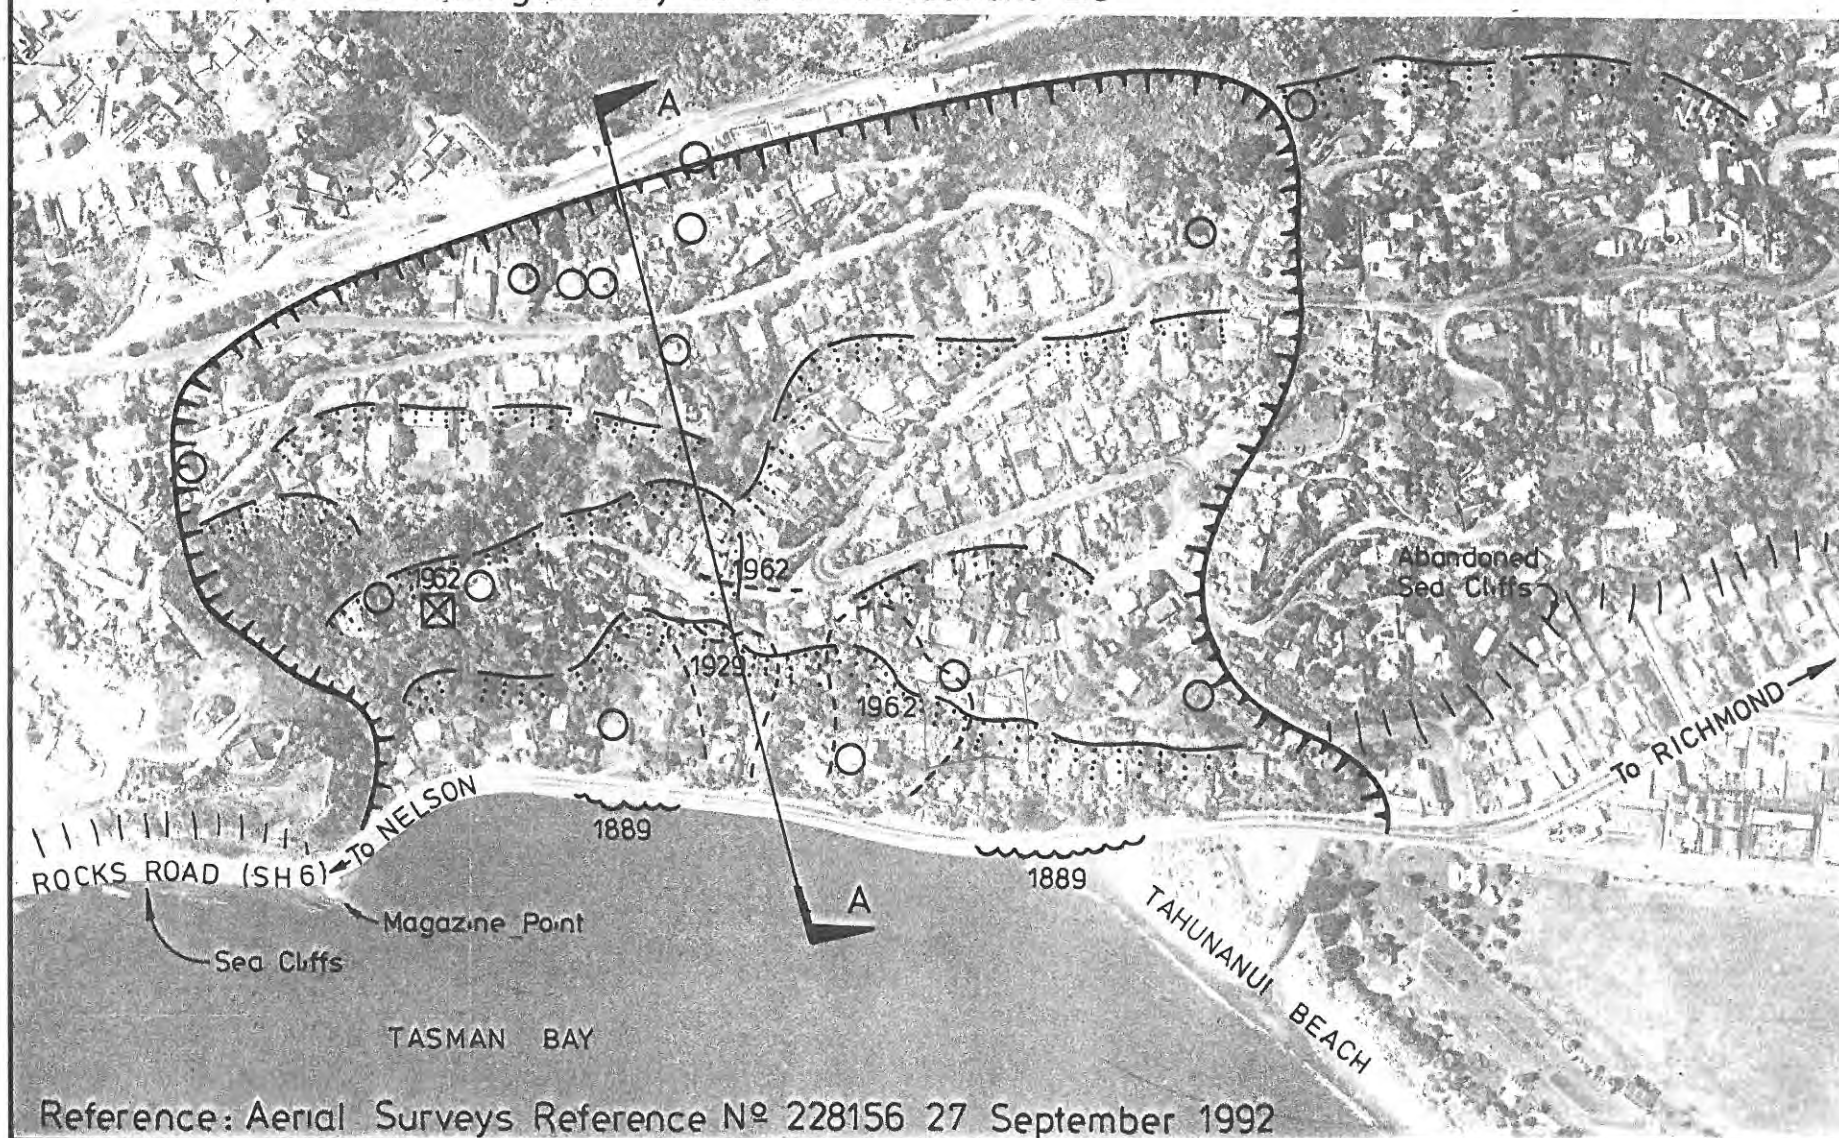
The approximate boundaries of the *Tahunanui Slump* as well as the major subsidiary failures within it are indicated in plan (Figure 1) and in schematic cross-section (Figure 2). The rates and nature of movements within these subsidiary blocks differ substantially as generally indicated by both the periodic resurvey records and the distribution and character of historic failures.

Approximate Extent of Main Subsidiary Failures

Approximate Extent of Damage Event (Year Indicated)

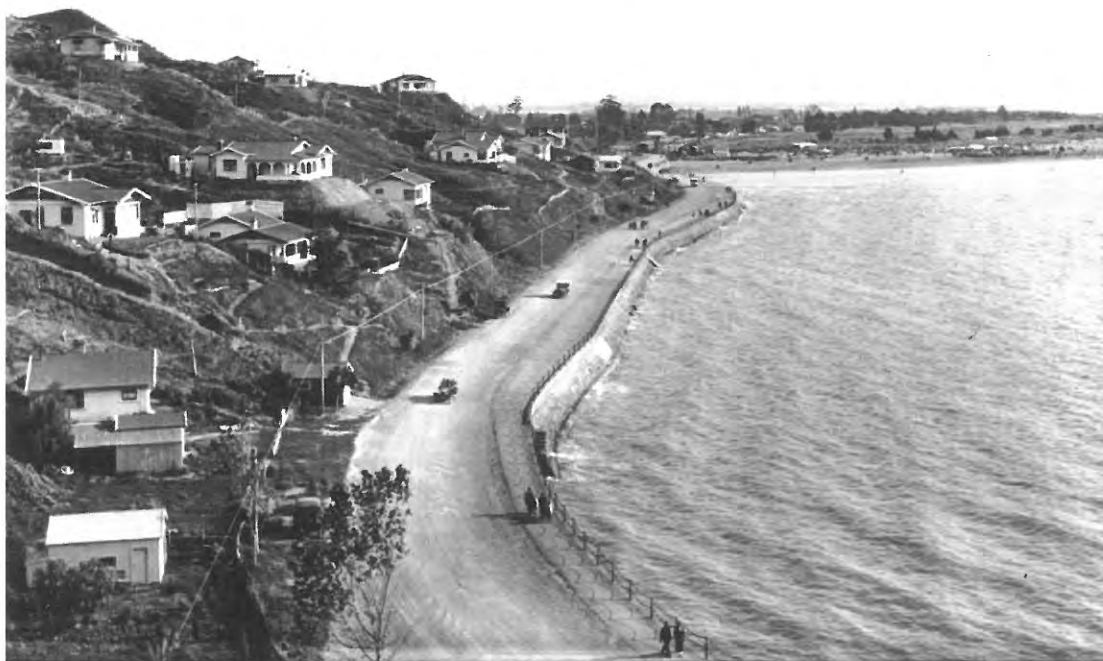
Rocks Road looking south from Magazine Point, late 1920's.
Model T in foreground is near the start of Days Track (Nelson Provincial Museum, F N Jones Collection).
